# CHEVROLET

1927 Chevrolet. Capitol, coach (with Alfred Sloan), JAC

# SPECIFICATIONS 1927

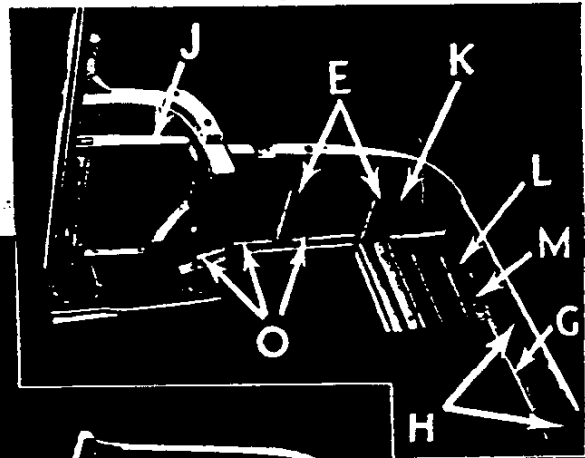
ILLUSTRATION NO. 131

*Cut-out showing differences of construction of main body sills in sport coupe*

Trim sticks, to which are attached the fibre board foundation of the deck compartment trim, are nailed to the top of the kick-up section of the sill at *O* in *Ill. No. 131*.

A metal plate is screwed to the lock pillar and the bottom board of the deck side compartment frame and acts both as a brace for these two members and as a stop for the door itself (see *Ill. No. 131*).

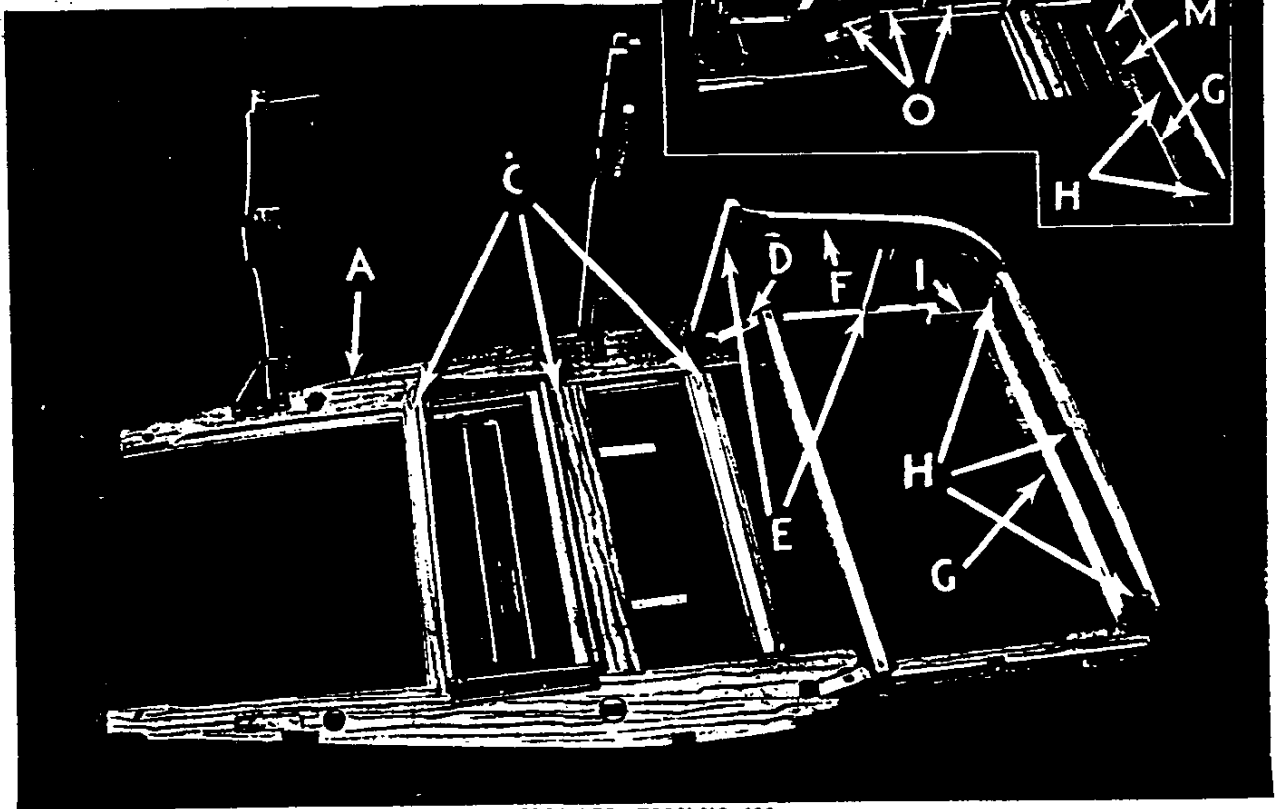
ILLUSTRATION NO. 130

*Shown above is construction of main body sill and attached wood members of business coupe (only right side shown)*

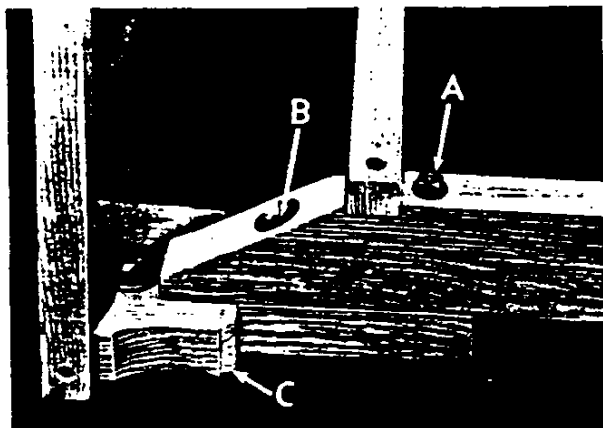
ILLUSTRATION NO. 133

Close-up of lap joint at kick-up section of main side sill assembly

A close-up (*Ill. No. 133*) shows the combination of lap

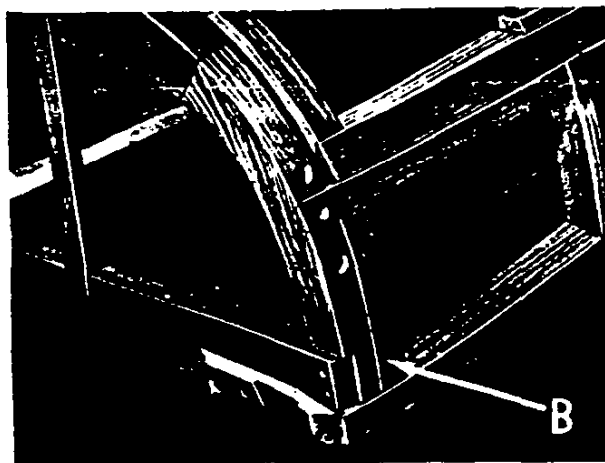
ILLUSTRATION NO. 133

Close-up of lap joints of rear and side sills and deck rail

joints which secures the main side sill to the rear cross sill and deck side rail. These joints are glued together and further secured by screws at both sides and bottom of the combined joint. This makes an exceptionally strong joint in the wood frame at a point that is subjected to unusual strains. The filler block to the right of the deck side rail on the business coupe body not only acts as a strainer but also serves as a foundation to which the deck lower panel is nailed (see *B in Ill. No. 133*).

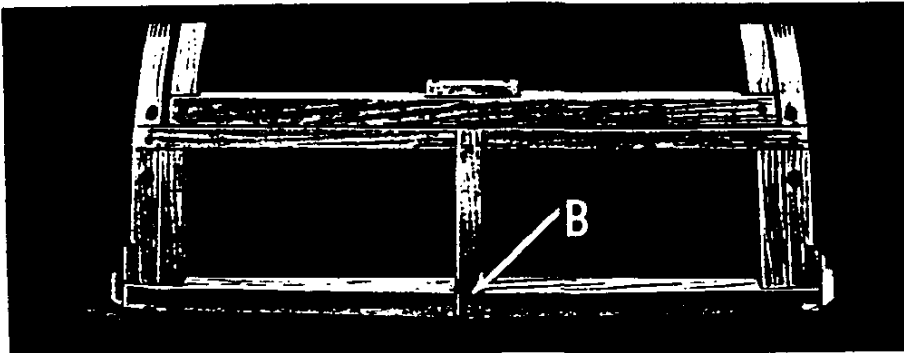
ILLUSTRATION NO. 133

Above—shows view of business coupe rear sill and attached members

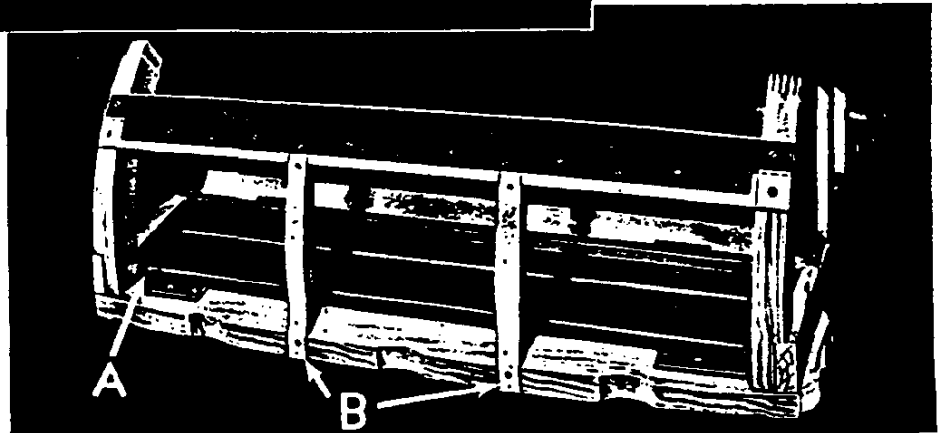
ILLUSTRATION NO. 135

At the right—shows view of sport coupe rear sill and attached members

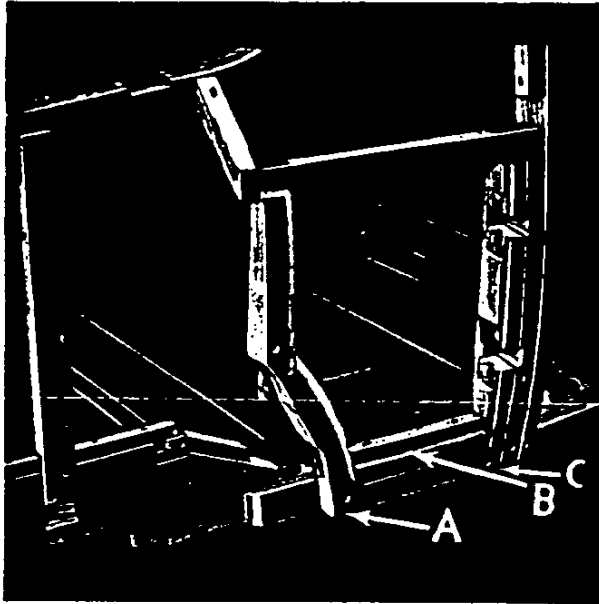
ILLUSTRATION No. 136

Section of side sill showing attachment of side compartment.

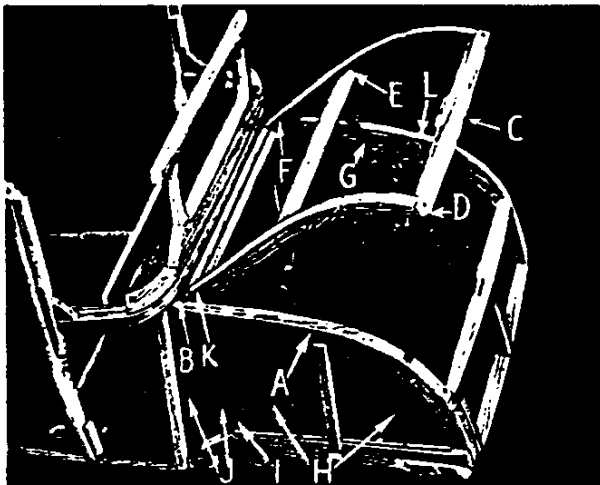
ILLUSTRATION NO. 137  
View of deck from the left side of business coupe

*Illustration No. 137*, looking from the left into the deck assembly of the business coupe, shows the construction of the deck side rail (A) bolted to the rear belt rail assembly (at B); the deck lid (C) with its side rails and three cross bars, the lock bar (at D) being joined to the deck lid side rail by a lap joint, the center bar (at E) by a mortise-and-tenon joint, and the hinge bar (at F) by a

lap joint. The deck lid hinge is screwed to the upper end of the deck side rail (at K). Near the center of the deck lid side rails, supporting arms are attached to brackets on the deck lid and the deck side rail (at G). A small metal stamping (at L) acts as a stop for the deck lid.

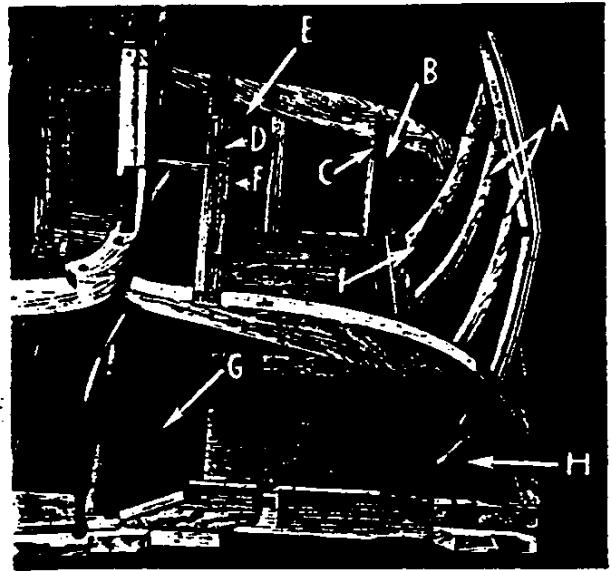
ILLUSTRATION NO. 138  
View of deck from the left side of sport coupe

*Illustration No. 138*, photographed in the same relative position as *No. 137*, shows clearly the differences in the deck construction between the sport coupe body and the business coupe body. This combination lid and rumble seat back has two supporting strainers (at A). The

deck lid swings on a pivot hinge (at B) which is bolted to an iron bracket (C) attached to the deck side rail and main side sill. These brackets also act as braces. The deck lid assembly is still further braced at the four corners by triangular blocks of wood glued and screwed to the frame of the lid (at I).

The deck lid lock bar is attached to the deck side rails by an open mortise (D in Illustration No. 138) and is braced at the center by a wood strainer to the back window frame. At the rear of the floor boards is nailed a metal drain pan (H) which extends to the rear cross sill.

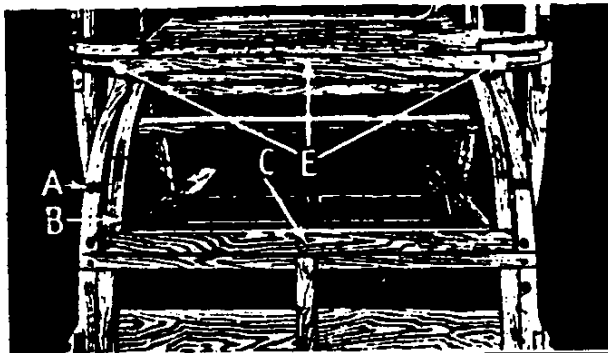
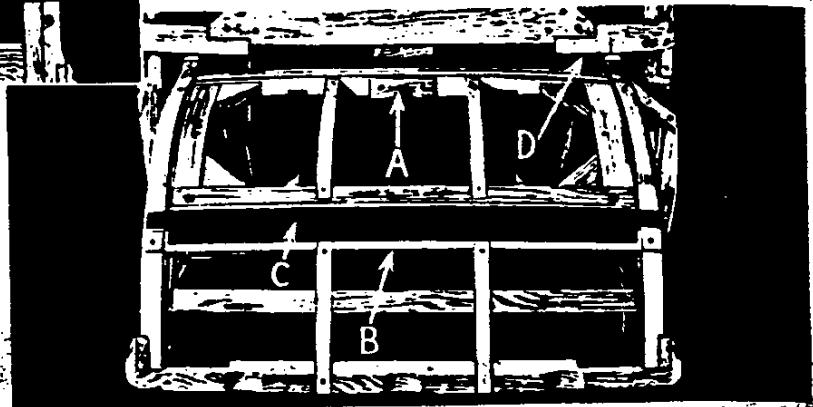
ILLUSTRATION NO. 139

Top—Rear view of business coupe deck

Bottom—Same view of sport coupe showing difference in construction

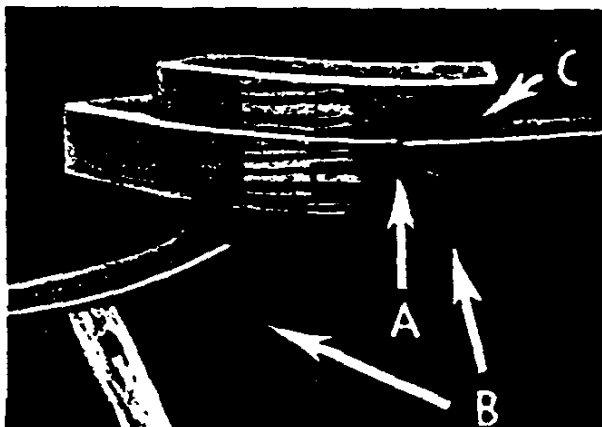
ILLUSTRATION NO. 141

Shows a close up of rear belt rail and deck side rail joint

**Noise in the rear belt rail.** If a noise appears to come from the rear of a coupe body, at either corner, examine the joint between the deck side rail and the rear belt rail. If this joint seems to be loose remove the bolt at

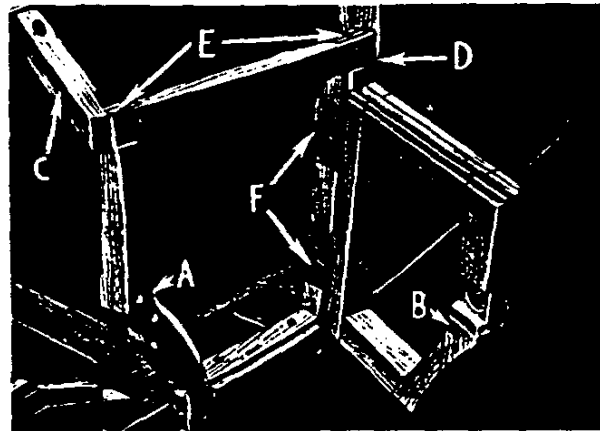
ILLUSTRATION NO. 142

Showing construction of right side compartment frame and door

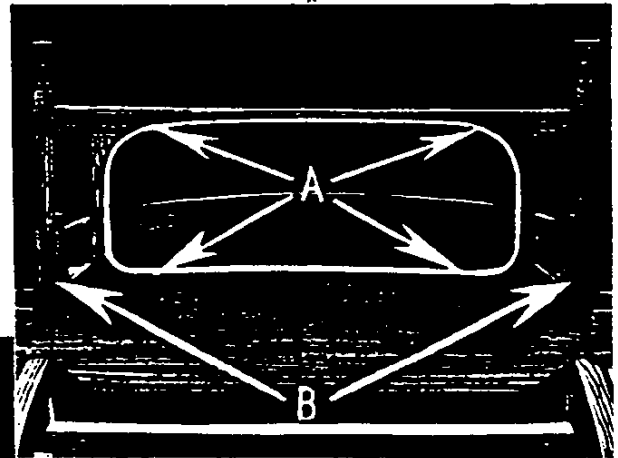
ILLUSTRATION NO. 143  
Shows rear view  
of back window framework  
in the business coupe

**BUSINESS COUPE BODY.** A rear view of the back window framework is shown in *Ill. No. 143*. Unusual strength in this assembly is achieved by first assembling the wood members in a jig, where they are accurately fitted, glued and screwed together, and then milled to the exact contour of the stationary window opening, thus affording

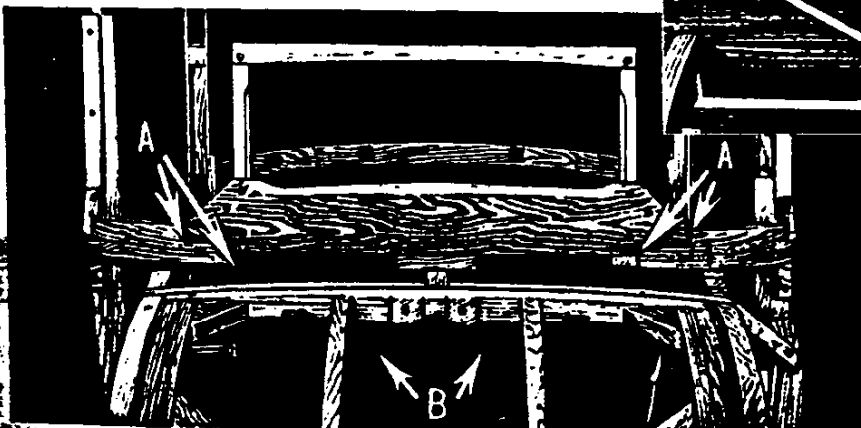
ILLUSTRATION NO. 144  
Shows similar view of the sport coupe

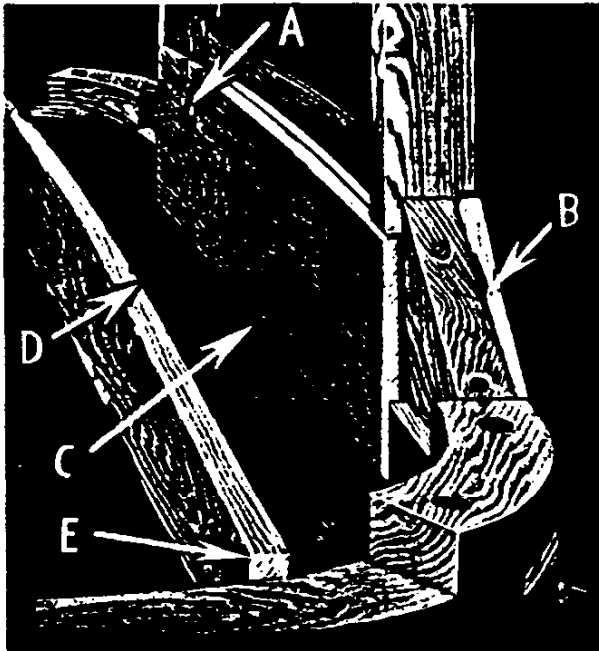
ILLUSTRATION NO. 145

Shows interior view of coupe seat compartment construction

Inside views of the seat compartment and the back window frame of the coupe body are shown in Ill. No. 145.

**Noise in seal compartment**—If the trouble is in the bottom board, loosen the screws by which the board is attached to the underside of the rear belt rail and insert friction tape. If the screw holes are oversize, insert wood plugs dipped in hot glue before reinstalling screws. If the trouble is in the upright front board, take out the screws which are inserted diagonally at both ends of the board, for they are usually the cause of squeaks at that point (*E* in *Ill. No. 145*). Dip the screws in friction paste F.S. No. 604 before replacing.

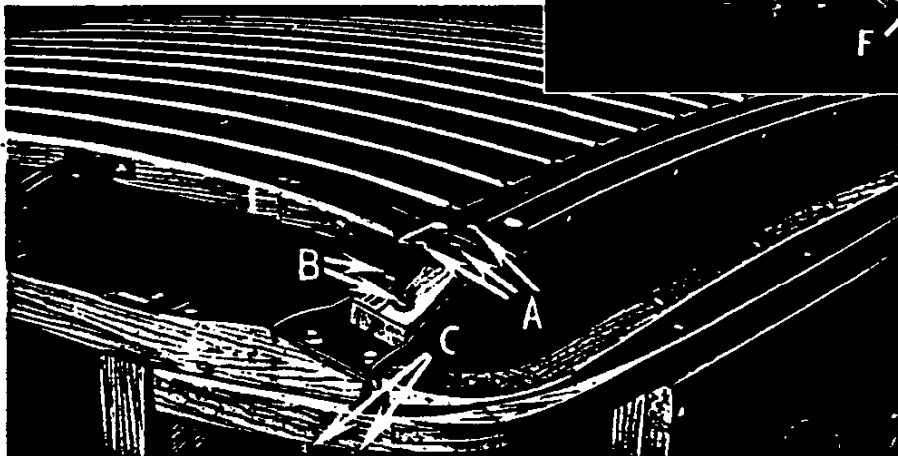
ILLUSTRATION NO. 146

Shows exterior view of rear roof rail corner bracket

Ill. No. 146 shows how the joints of the rear roof bow and the crown roof rail are reinforced by being bolted together to the rear corner bracket (at points A). The rear roof bow is also bolted to this iron bracket (at points B) instead of being joined directly to the side and rear roof rails, as in the former construction. At C are indicated two long bolts that secure the bracket to the rear and side roof rails. This construction adds so much strength and resistance to weaving that the metal strainers which formerly extended from the rear roof bow to the rear roof rail are no longer required.

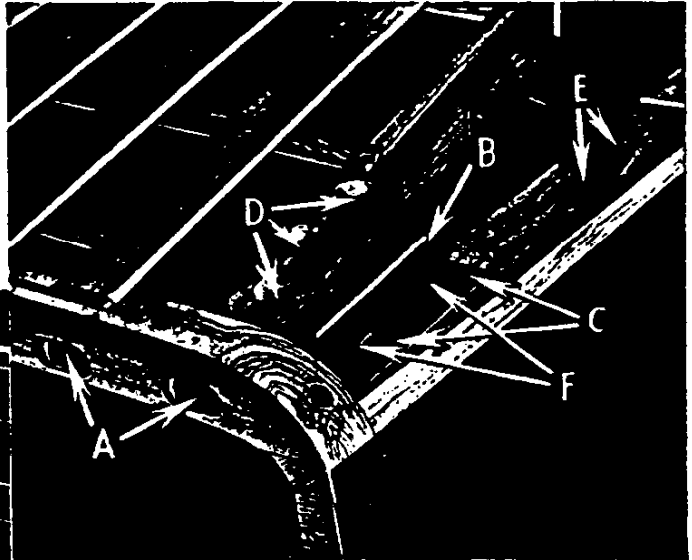
ILLUSTRATION NO. 149

Shows view from top of front corner roof rail bracket

A view of this bracket through the top of the roof shows two bolts set in anchor plates which are inserted in cut-out slots on the front roof rail (see *A* in *Ill. No. 149*). This improvement overcomes any possible difficulty of adjustment at this point that may have formerly been caused by the nuts turning with the bolts.

Another important change in the construction of the bracket is shown at point *B* in *Ill. No. 149*. In the earlier design this bracket extended downward and was

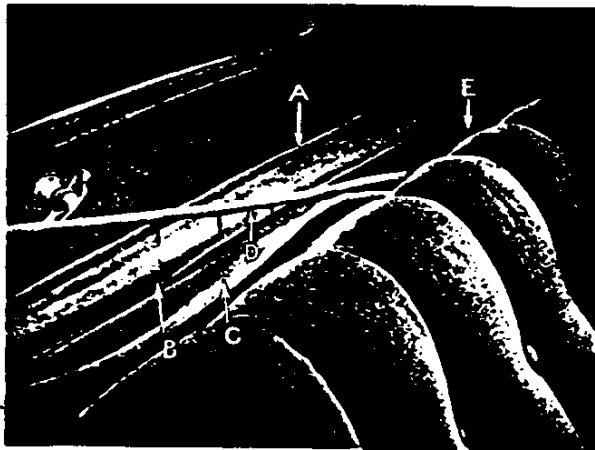
ILLUSTRATION NO. 156

Showing coupe seat valance extended for forward adjustment of seat and partially disassembled at left to show Randall moulding
